# Heat Exchanger Tube Sheet Reliability Analysis

KANNAN SUBRAMANIAN, PhD, PE, FASME

DAN PARKER, PE

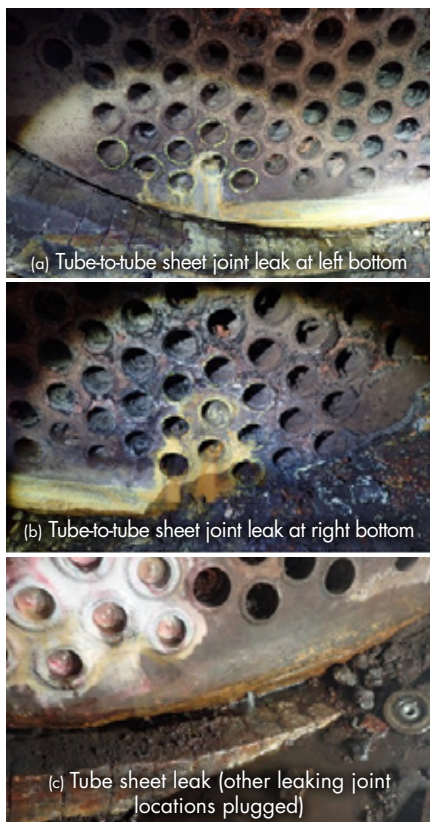
approaching the end of service life where tube failure frequency increases.. As typical, there may be a single tube leak or several in the same proximity (Figure 2). Some proactive plugging has been applied based on historical performance (Figure 3(a)). In SI's experience, tubes adjacent to a plugged tube may fail a short time after the plug is installed as there is an undefined temperature/stress interaction. In addition to tube leaks, general corrosion and tube sheet thinning can be a consequence of tube leaks (Figure 2(c)). Excessive tube sheet thinning is not uncommon due to the formation of sulfuric acid that exacerbates the corrosion issue. With these consequences in mind, it is critical that the proper number of tubes be plugged to stop the costly cascade of failures.

FIGURE 2. Tube-to-tube sheet joint failures and tube sheet leak

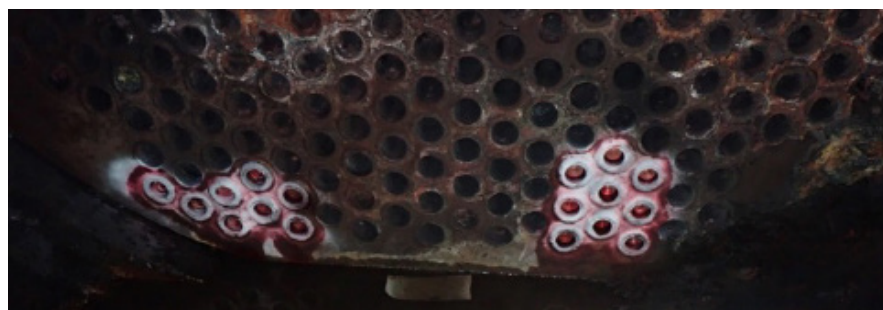
(a) Plugged tube-to-tube joints

To bring the boiler back to service, in early January of 2022, the leaking tubes and a few other tubes around the leaking tubes were plugged. In addition, to repair the leaking location in the tube sheet knuckle region, welding followed by post-weld heat treatment was performed (Figure 3(b)). Within a few weeks after this repair, additional tube leaks were discovered and required plugging. Such frequent leaks and repairs result in production loss and unplanned expenses. To minimize those, SI was contracted to develop an engineering basis for tube plugging, which would be proactive for equipment reliability, but not produce over-plugging that affects the boiler heat duty. To achieve this, the engineering assessment should involve an advanced analytical study to understand the following:

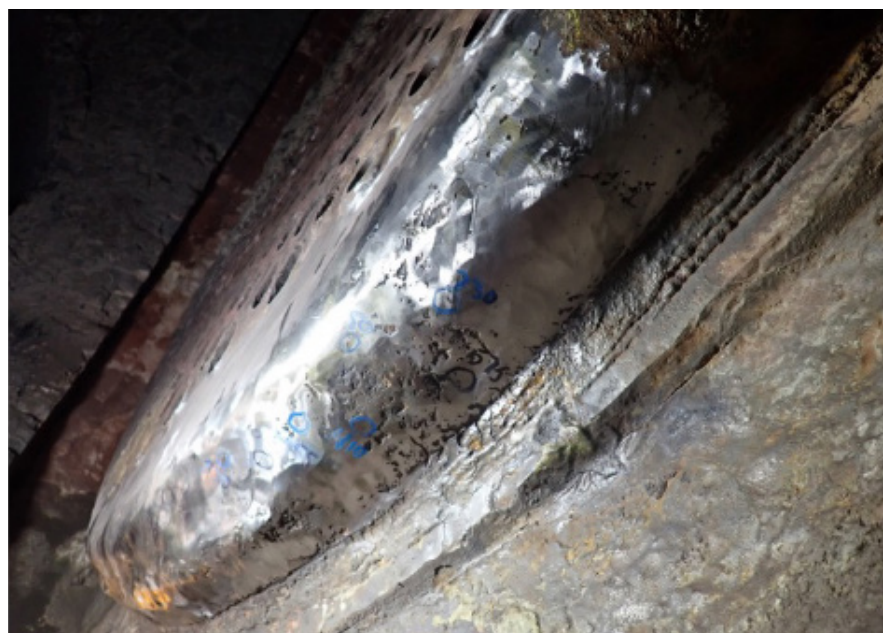
(b) Tube sheet repair at the bottom leak location

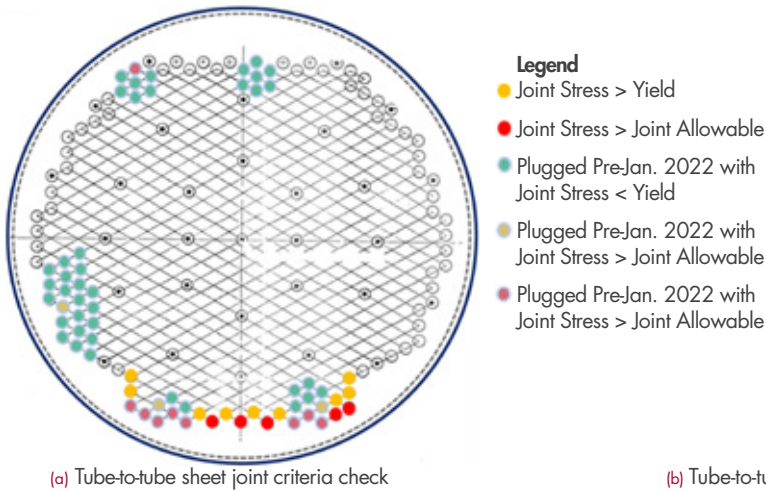
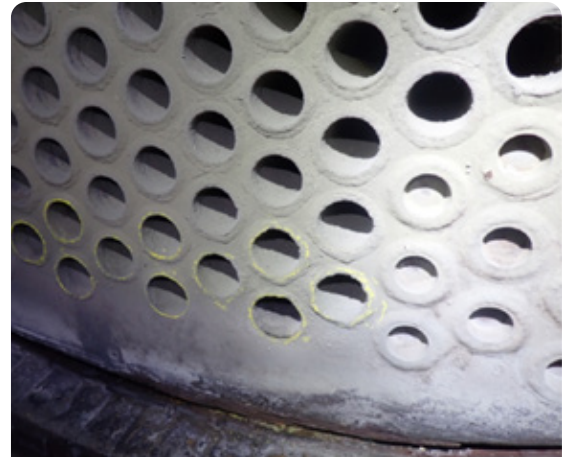
FIGURE 8. Post Repair and Plugging Process Conditions Criteria Check and Field Observation

Since the number of tubes is significant, post-processing of results is a challenge. SI developed a procedure to overlay the von Mises equivalent stress results on a spreadsheet layout that resembles the actual tube layout in the tube sheet. It is further simplified for better visualization in this article, as shown in Figures 8 through 10. Figure 10 (a) shows a historical perspective of the tube plugging over time. In the first set of analyses that SI performed, only the locations shown with greyish blue color (tubes plugged before Jan. 2022) were considered as plugged. The thermal analysis results for this case are shown in Figure 7. After performing the mechanical/stress analysis, it was observed that the unplugged tube locations shown in Figure 8 (a) with orange and red dots are of concern.

The orange dot locations indicate the locations with stresses greater than the tube yield strength. The red dot locations indicate that the stresses exceeded the allowable stress. Since the criteria are set at joint location stresses exceeding the tube allowable stresses, both orange and red dot locations require tube plugging. Figure 8 (b) shows the locations where further tube leaks were discovered within weeks of the weld repair and plugging. The tube leak locations are identified with yellow marks. This gives the confidence that such analytical methods, when appropriately applied, can predict the locations of future failures.

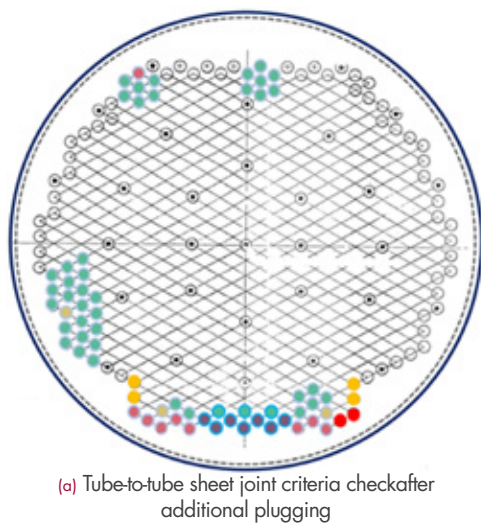
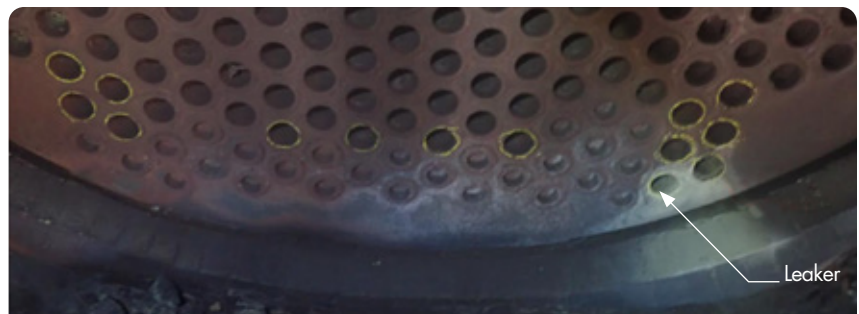
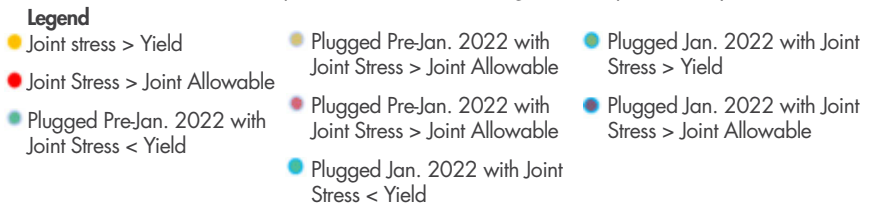
FIGURE 9. Additional Plugging and Field Observation after that Plugging

After the discovery of the new leaks, further plugging was undertaken. These locations are identified by light blue dots in Figure 10 (a). SI incorporated these changes in the analyses and determined that the locations shown in red and orange dots in Figure 8 (a) are still a concern, as shown in Figure 9 (a). This was later confirmed by further tube leaks (see Figure 9 (b)) found after 6 weeks of the previous plugging was completed. This further assured the value of performing such an engineering-based approach rather than a traditional grand-fathering approach which would use plugging methods adapted for similar units based on historical information. It should be noted that SI was engaged in this study

(b) Tube-to-tube sheet joint leak at location of high stresses predicted by FEA

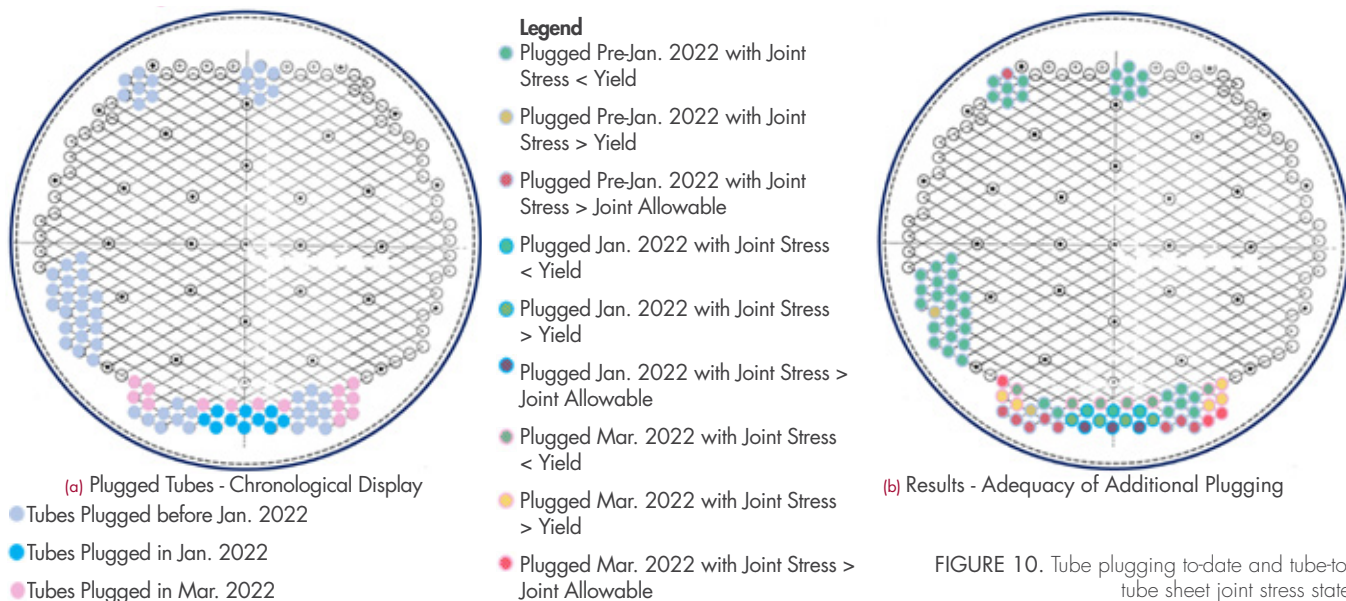
at the period between weld repair and second set of plugging as shown in Figure 8. However, all the results were made available just prior to the third leak shown in Figure 9 (b). At this time, the Client utilized the results from the FEA and decided to add additional tube plugging as shown in Figure 10. SI performed analyses with the final set of plugging, and the results indicated that other tube locations around the plugged tube locations are not of concern (see Figure 10 (b)).

FIGURE 10. Tube plugging to-date and tube-to-tube sheet joint stress state
