# Materials Laboratory Case Studies

## Case Study #2 | Manufacturing – Supply Chain Upsets

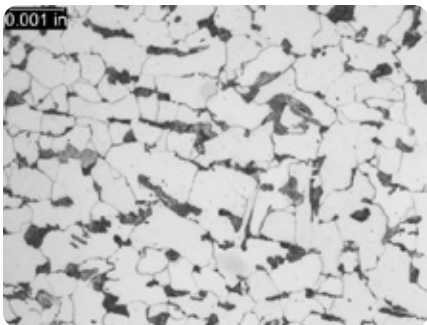
FIGURE 2. The typical microstructures from the marked sample **TOP** and the unmarked sample **BOTTOM**

Cross sections were removed from both samples and prepared for metallographic examination. The microstructures from each are shown in Figure 2. The newer material (sample marked "F") had a microstructure

consisting of pearlite in a ferrite matrix. The previously supplied material had a microstructure consisting of Widmanstätten ferrite and bainite. Hardness measurements were made on each prepared sample. The F sample had an average hardness of 66.7 Rockwell B and the unmarked sample had an average hardness of 90 Rockwell B. The measured hardness values were consistent with the observed microstructures.

The pearlitic microstructure and lower hardness value indicate that the newer material would have a lower tensile strength than the older material, which was likely the reason it was not performing as expected in its final application. Armed with this information the manufacturer has the information necessary to resolve the issue with the supplier.
