Materials Laboratory Case Studies

Case Study #5 | Process Upsets – Condition Analysis

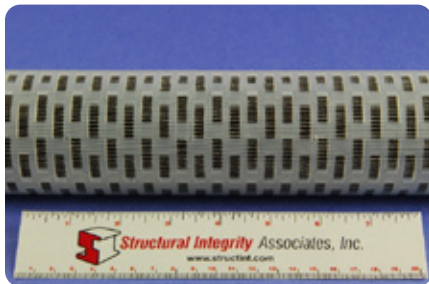
FIGURE 1. The filter shown in the as-received condition.

A filter was removed from a stator cooling system after pressure differential sensors indicated it may be blocked. The filter was submitted to SI's Materials Laboratory for analysis to help identify the material blocking it.

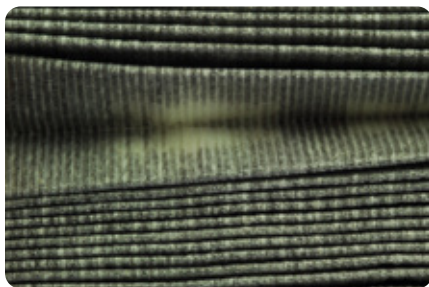
FIGURE 2. The yellow color is the original appearance of the filter.

The filter was visually examined and documented in the as-received condition as shown in Figure 1. The submitted sample had a perforated plastic shell that covered an inner filter. The outer plastic was removed to provide access to the filter underneath. Figure 2 shows close images of the filter, which was yellowish-white with much of its surface covered in gray colored debris/deposit.

A portion of the filter was scraped to remove the deposits. Another portion of the filter was removed and soaked in Methyl Ethyl Ketone (MEK) to remove the debris present on the filter. The solvent evaporated and the remaining particles were collected. Both samples were analyzed in a scanning electron microscope using energy dispersive X-ray Spectroscopy (EDS) to identify the elements present. The results are provided in Table 1. The results indicate that the filter debris was primarily copper oxide. Plant personnel reported that copper contamination could

be occurring in the system, so these findings appeared to be consistent with plant information. With their suspicions confirmed, plant personnel were able to move forward with mitigation steps for keeping the filters from becoming blocked.
