# Heat Exchanger Tube Sheet Reliability Analysis

KANNAN SUBRAMANIAN, PhD, PE, FASME

DAN PARKER, PE

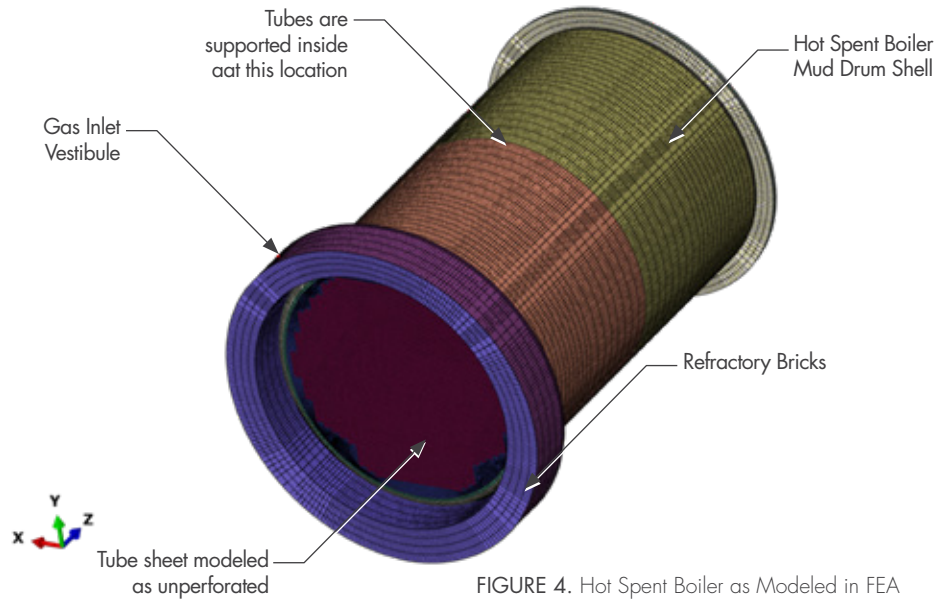
FIGURE 4. Hot Spent Boiler as Modeled in FEA

Since the methodology requires the use of advanced analytical methods, an FEA model (Figure 4), was built and analyzed using the commercial FEA software package – Abaqus. The model included sufficient lengths of gas inlet and outlet sections, the tube support location at the mid-section of the mud drum, the refractory, and the brackets that connect the hot section with the boiler drum. Since the nozzles are far from the area of interest, they are not included in the model. Appropriate element types were utilized for this work. One notable feature is the use of beam elements for the tubes (Figure 5). Since the model includes hundreds of tubes, incorporating a

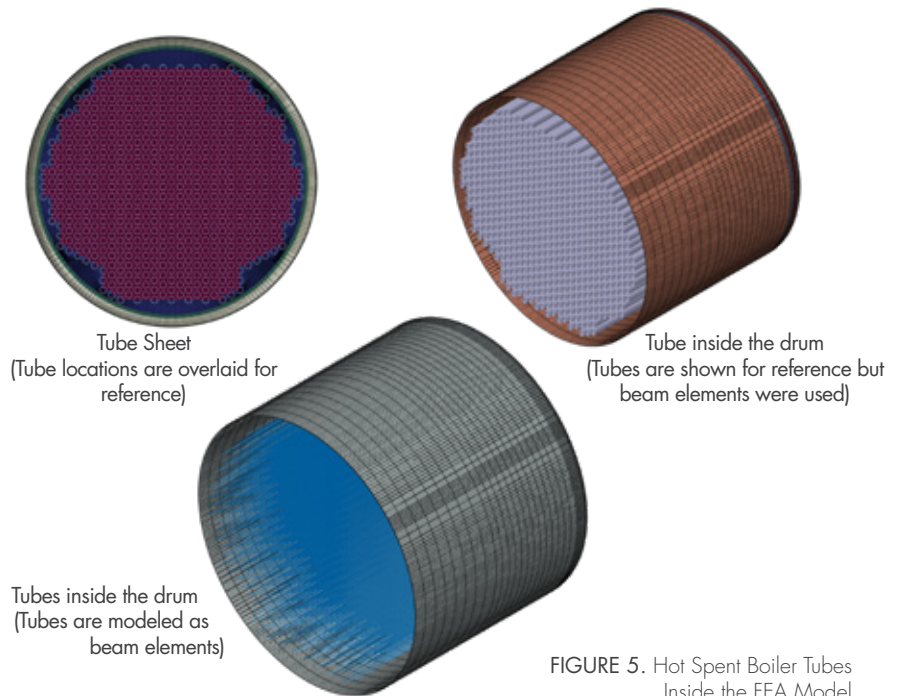
FIGURE 5. Hot Spent Boiler Tubes Inside the FEA Model

solid tube and heat exchanger model adds both geometric and numerical complexity. The use of beam elements simplifies the model while significantly minimizing the numerical convergence issues when compared with the full solid models.

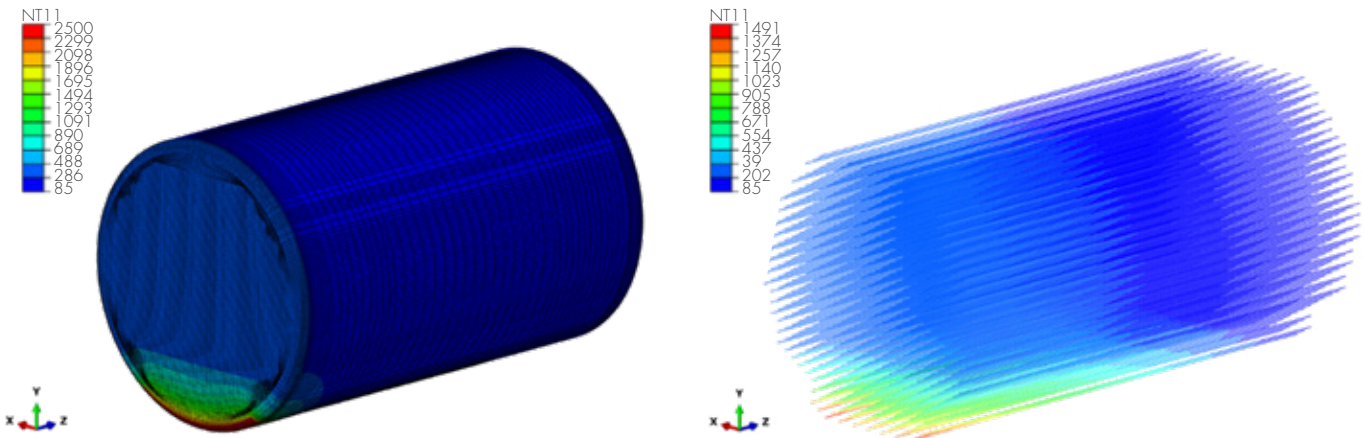
FIGURE 6. Repair Welding Simulation – Heat Transfer Analysis

of steps is critical. SI discussed the methodology with the client when developing the accurate sequence to be included in the FEA. As stated earlier, to capture the effect of residual stresses (after welding and PWHT processes) on the corroded tube sheet section at the bottom where the leak was discovered, an elastic-plastic FEA is essential. Temperature results from the welding process step are shown in Figure 6. After welding and PWHT, the process conditions were applied to the model along with the number of plugged tubes at the time. Figure 7 illustrates the temperature distribution in the tube sheet, boiler drum, and tubes. Since the plugged tubes do not transport flue gas, the temperature of those tubes is the same as the water temperature around those tubes inside the drum.

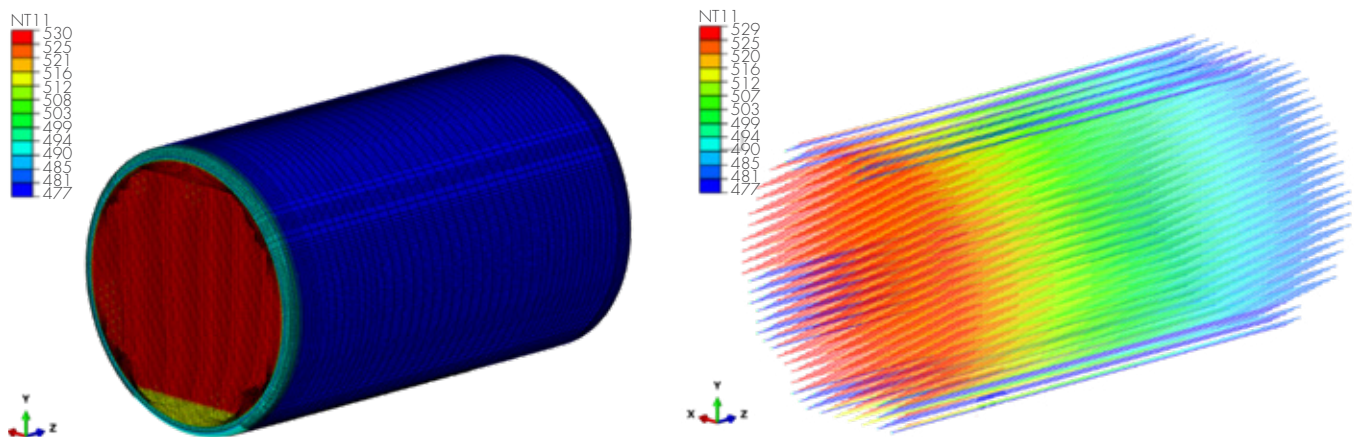
FIGURE 7. Post Repair and Plugging Process Conditions – Heat Transfer Analysis

Since the number of tubes is significant, post-processing of results is a challenge. SI developed a procedure to overlay the von Mises equivalent stress results on a spreadsheet layout that resembles the actual tube layout in the tube sheet. It is further simplified for better visualization in this article, as shown in Figures 8 through 10. Figure 10 (a) shows a historical perspective of the tube plugging over time. In the first set of analyses that SI performed, only the locations shown with greyish blue color (tubes plugged before Jan. 2022) were considered as plugged. The thermal analysis results for this case are shown in Figure 7. After performing the mechanical/stress analysis, it was observed that the unplugged tube locations shown in Figure 8 (a) with orange and red dots are of concern.

The orange dot locations indicate the locations with stresses greater than the tube yield strength. The red dot locations indicate that the stresses exceeded the allowable stress. Since the criteria are set at joint location stresses exceeding the tube allowable stresses, both orange and red dot locations require tube plugging. Figure 8 (b) shows the locations where further tube leaks were discovered within weeks of the weld repair and plugging. The tube leak locations are identified with yellow marks. This gives the confidence that such analytical methods, when appropriately applied, can predict the locations of future failures.
